Storm Damage Report

El Nacional Spanish Newspaper
304 SW 25th Street
Oklahoma City, OK 73109

FIELD REPORT FOR INITIAL STORM DAMAGE INVESTIGATION

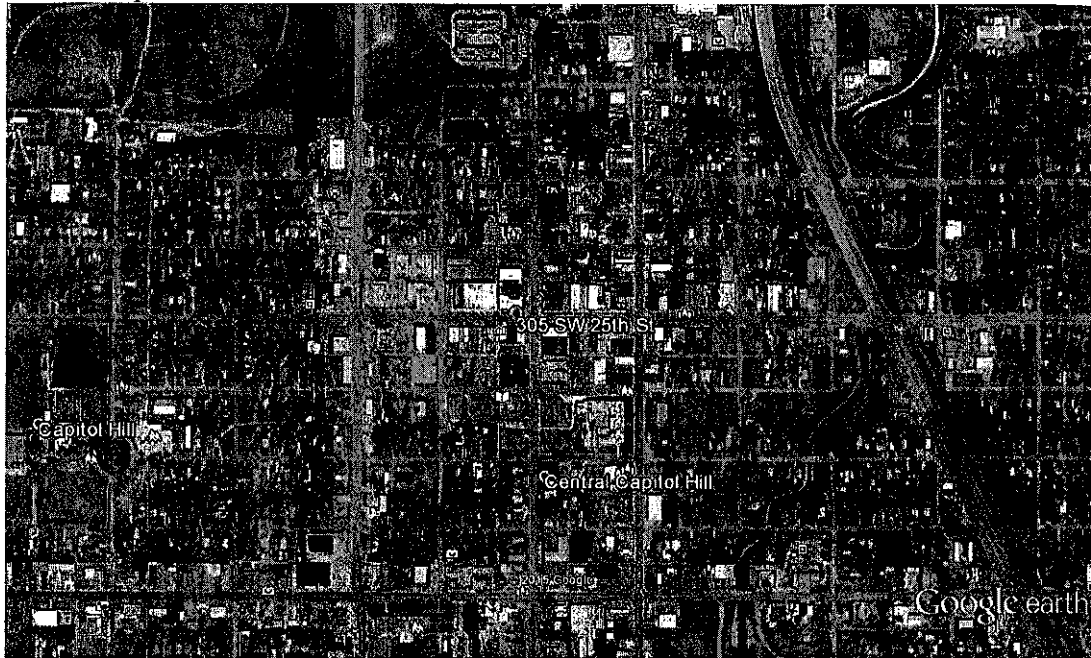
1.11 Inspection Notes

- Area is surrounded by single story commercial/industrial properties inconsistent with the definition of Exposure B in ASCE 7. This property falls in Exposure C in ASCE 7.
